# HUDSON CLUTCH ADJUSTMENT

## Mechanical Linkage factors

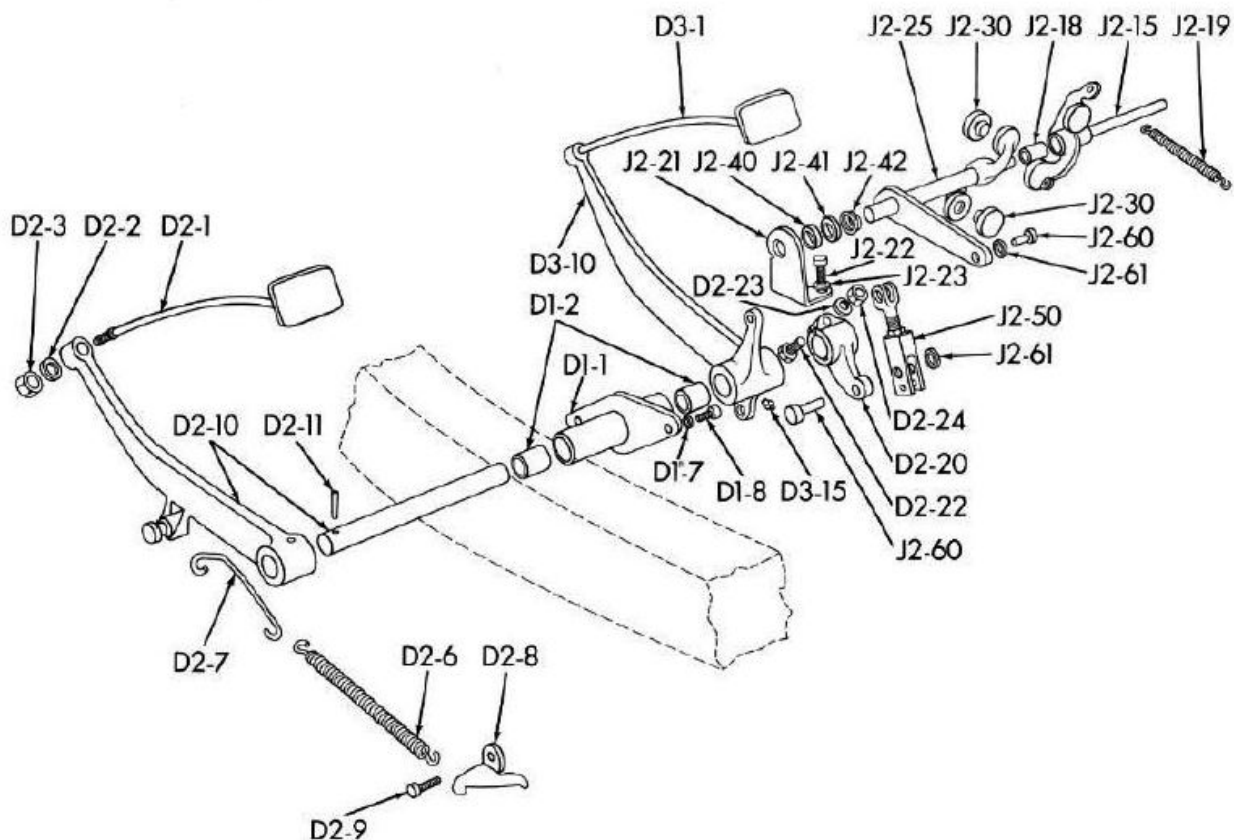
Item J2-21 is a bearing point for item J2-25 which is connected to the bell housing via J2-15 to operate the clutch throw out bearing. J2-21 and J2-25 are tightly held to each other by the pressure exerted on them by the clutch counter spring D2-6. This pressure is sufficient to cause significant wear on both the bearing hole in J2-121 as well as the J2-25 shaft that rides in that bearing hole. This should be inspected for wear on each clutch service and repaired as required. Adjusting a clutch with damage at these points will be difficult at best and will definitely distort the clearances desired.

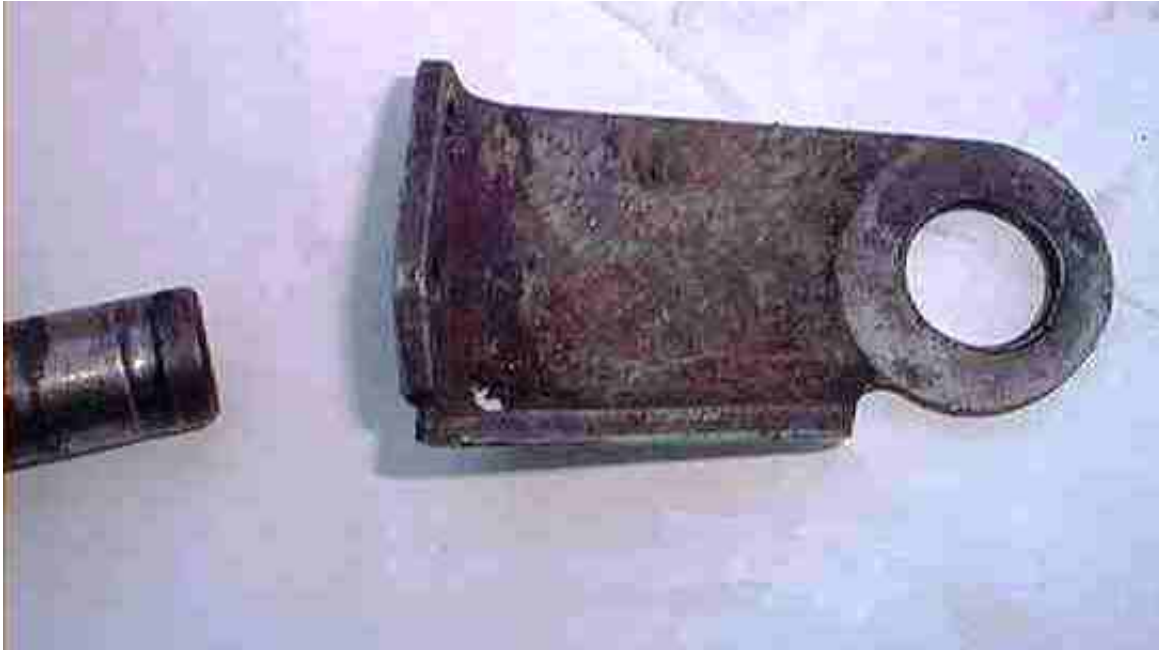
Wear on J2-21 and J2-25 is shown in the following pictures. The out of round wear on J2-21 was repaired by welding the hole and re-boring to an ID that would accept an OILITE bearing pressed into the mount hole. The ID of the OILITE bearing was selected to match the repaired OD of J2-25 repaired shaft end. The shaft on J2-25 was welded and ground back to the proper OD.

**Pressure from shaft riding on the fixed mount has worn the mounting hole oblong**

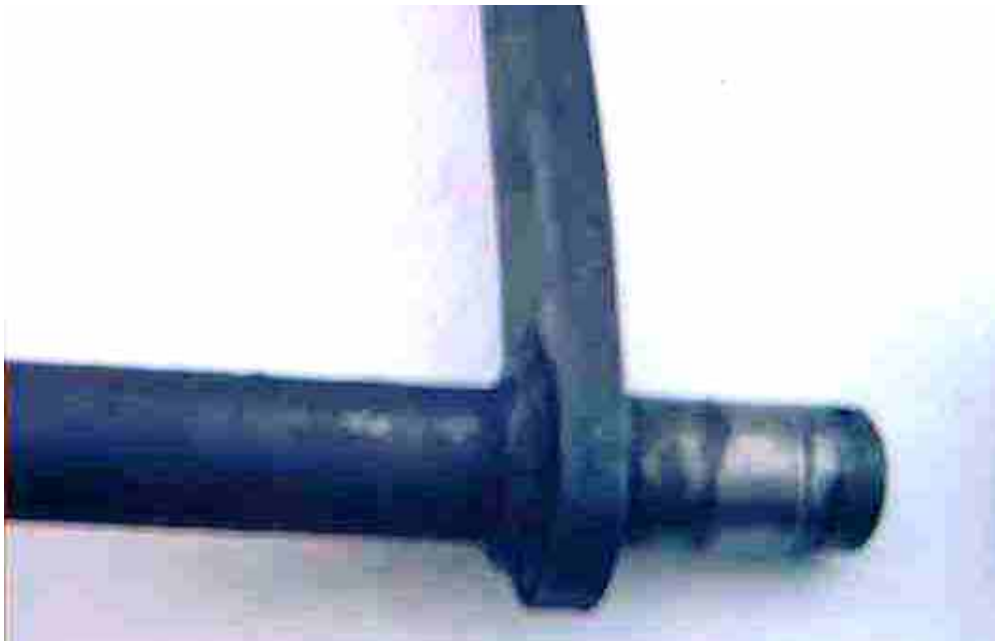
**Fixed mount has worn a groove into the shaft**

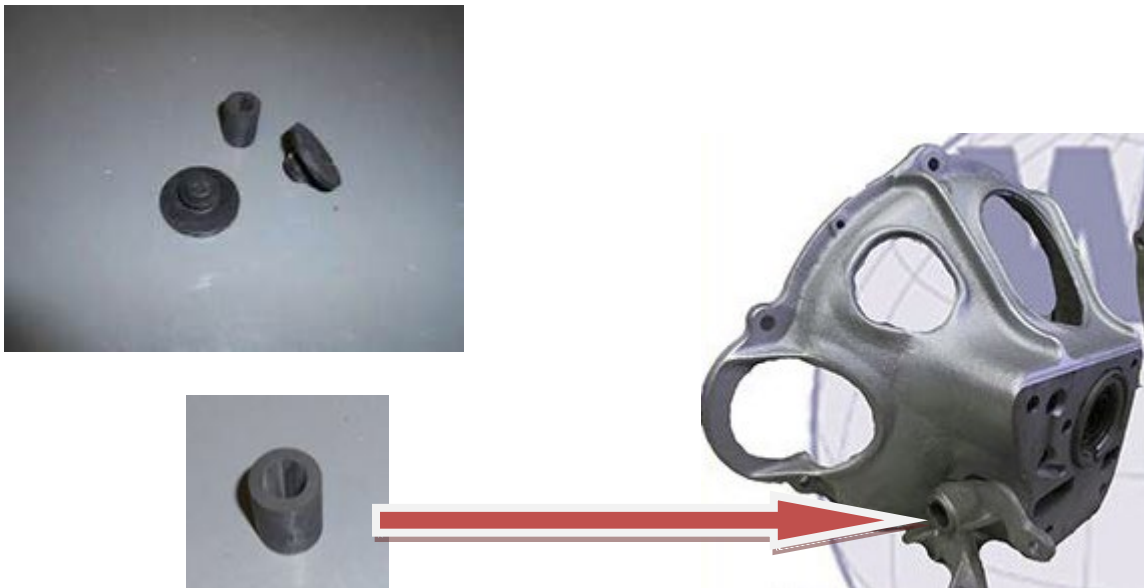
The cross shaft linkage J2-15 mounts one set of the clutch cross shaft pads and the bell housing end of that linkage has a hole into which the rubber bushing J2-18 is inserted. That rubber bushing supports the other end of J2-25 . If these rubber components (including J2-30) are worn or as is usually the case failed, they need to be replaced to obtain clearances required to properly attain factory clutch adjustments. Wildrick Restorations offers a cushion kit which includes rubber components J2-18 and J2-30. In the following diagram the arrow points to where the rubber bushing mounted on the end of J2-25 is inserted. This rubber bushing around one end of J2-25 linkage and the fixed mounting hole on the other end along with new J2-30 cushions "SET The static linkage adjustment. Without all of these mounting points being correct the linkage adjustment will be difficult if not impossible to correctly accomplish .

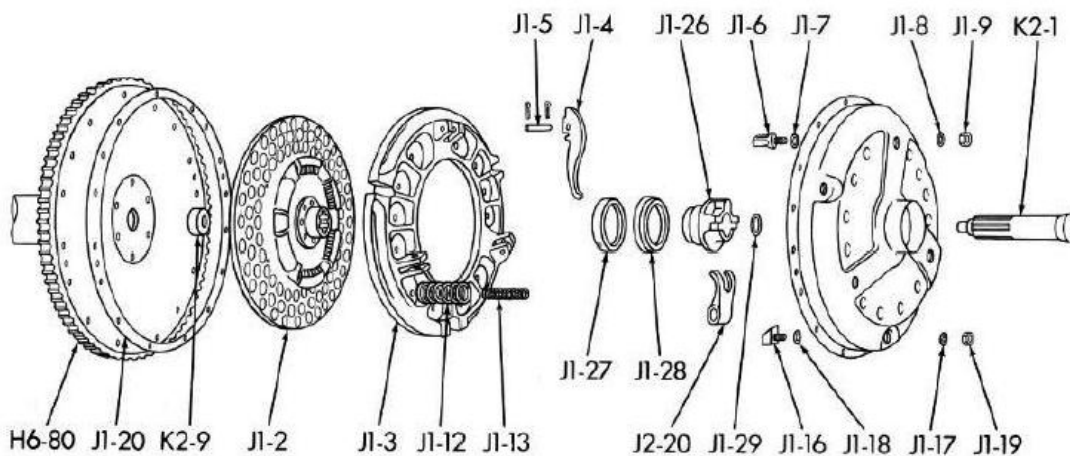
Item J2-15 in the diagram above is attached to the bell housing with a set of mounting pins. This shaft bears a huge amount of force when the clutch pedal is engaged. It is responsible for operating the mount J2-20 that locates the clutch throw out bearing. The shaft is supported in the bell housing with bushings that when worn-out cause J2-20 to improperly operate the throw out bearing.

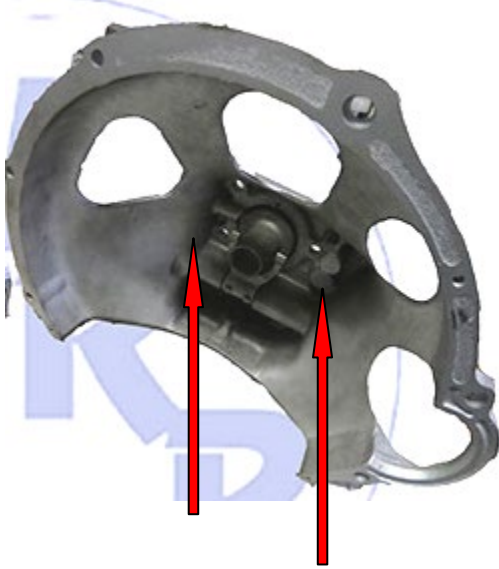
The red arrows point to the area in the bell housing shown in the attached picture where the bushings that support throw out bearing shaft J2-15 are located.
